Market Barriers to the Uptake of Biofuels Study

A Testing Based Assessment to Determine Impacts of a 10% and 20% Ethanol Gasoline Fuel Blend on Non-Automotive Engines

Report to Environment Australia

Orbital Engine Company

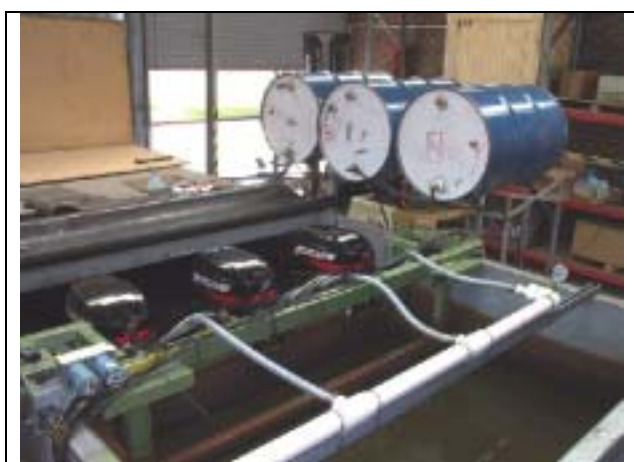
Figure 4.2.1 Marine Engine Durability Testing

All engines were run concurrently next to each other in a dedicated marine tank (see Figure 4.2.1). The geometry and water volume of the tank, as well as the spacing between the engines, was selected such that the effect of water motion from one engine to another was minimised as much as practicable or as according to manufacturer's specifications where possible.

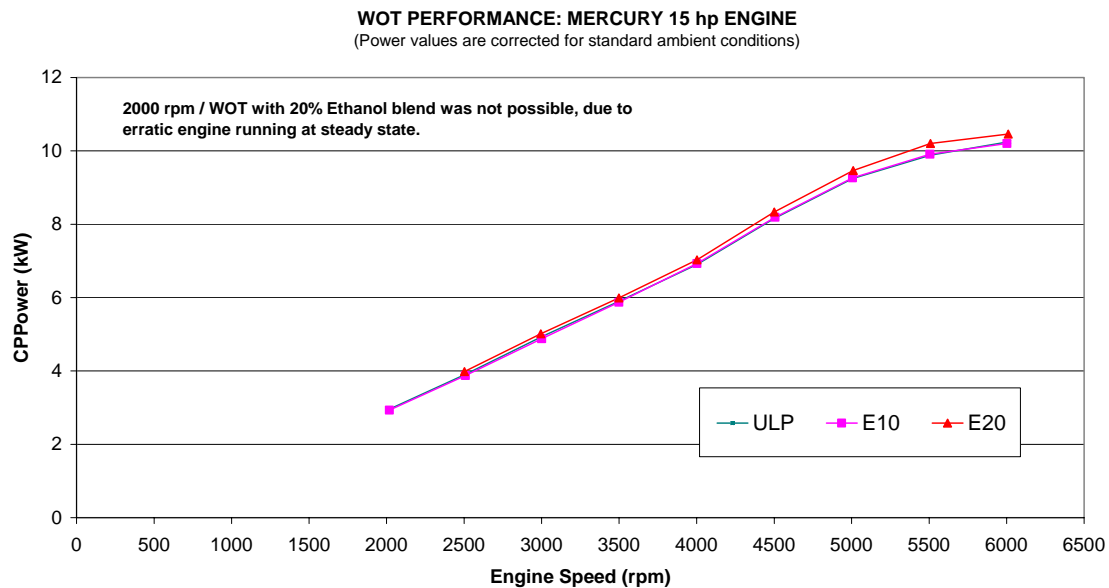
Figure 5.1.2 Marine Engine WOT Power Results

WOT Performance was assessed for each of the three fuel blends in the 2000 to 6000rpm range in increments of 500rpm.

Figure 5.1.2 indicates that the performance is similar for ULP and E10. Power when operating with E20 is consistently higher than with the other fuel blends by between 1 to 3%. Closer examination of the recorded data confirms that for the given carburettor setting, the resulting equivalence ratio with E20 is leaner than for ULP and E10 tests and more closely matches the “best torque” calibration. The majority of two stroke engine manufacturers specify “rich of best torque” settings to provide tolerance to a range of operating factors and improve engine reliability. However, it was not possible to record E20 results for the 2000rpm point due to the very erratic operation of engine potentially caused by operation at leaner than stoichiometric A/F ratio conditions (see section.5.1.1.1.3).

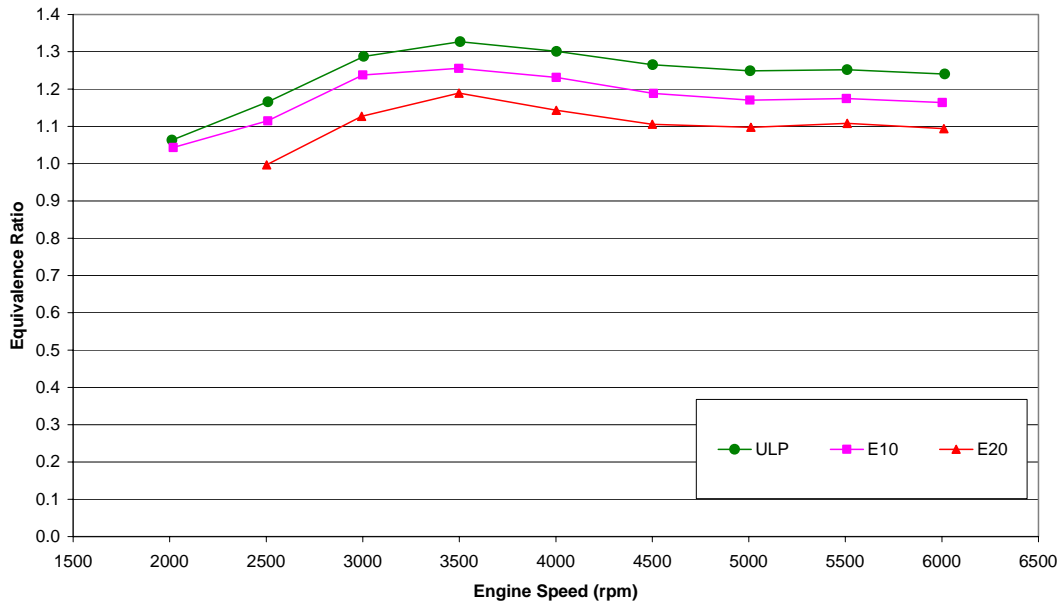
Figure 5.1.4 Marine Engine Equivalence Ratio for WOT Tests

The measured equivalence ratio throughout the engine operating range is shown in Figure 5.1.4. Stoichiometric engine operation occurs at an equivalence ratio of 1.0, which for the E20 fuel blend is reached at the 2500rpm point. At the 2000rpm point the equivalence ratio is expected to be leaner, resulting in conditions that are unsuitable for the stoichiometric or richer homogeneous combustion conditions required for this particular engine design.

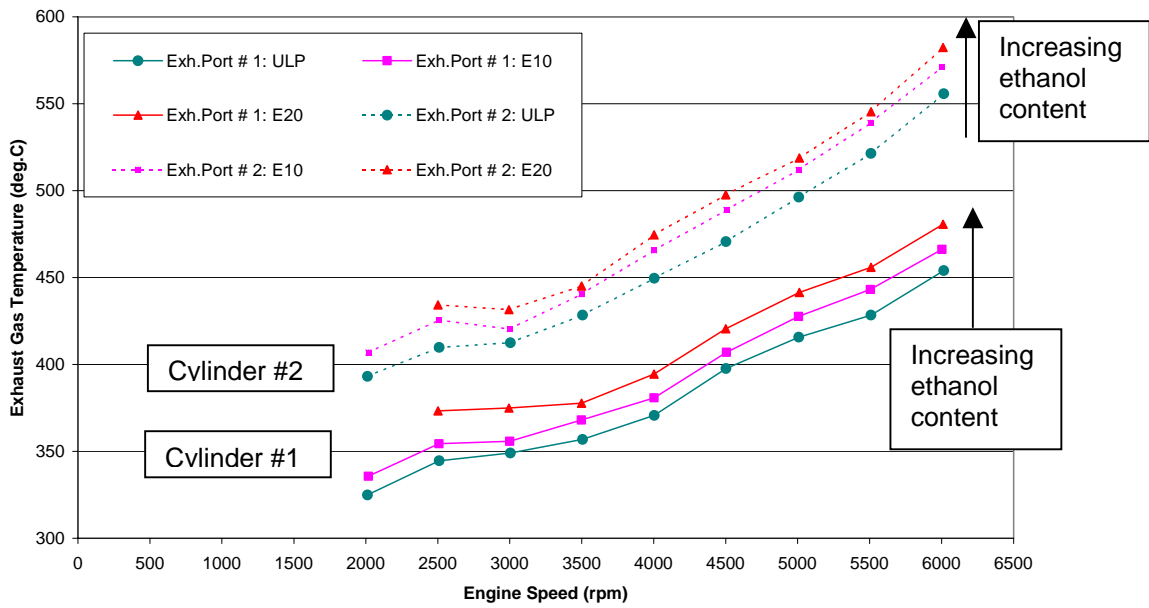
Figure 5.1.5 Marine Engine WOT Exhaust Temperatures

The data gathered during the investigations also confirmed the expectation that exhaust gas temperatures would rise as a result of operation on ethanol blended fuels. The data in Figure 5.1.5 shows the exhaust port gas temperature results for both cylinder #1 and #2. There is a clear trend of increasing exhaust gas temperature as a function of increasing ethanol content in the fuel blend. The magnitude of temperature increase is of the order of 30°C for 20% ethanol. The trend is similar for both cylinders, with cylinder #2 temperatures being higher than those of cylinder #1. The cylinder to cylinder variation is possibly due to a number of factors but could be related to coolant flow within the engine and the precision to which the thermocouples were located.

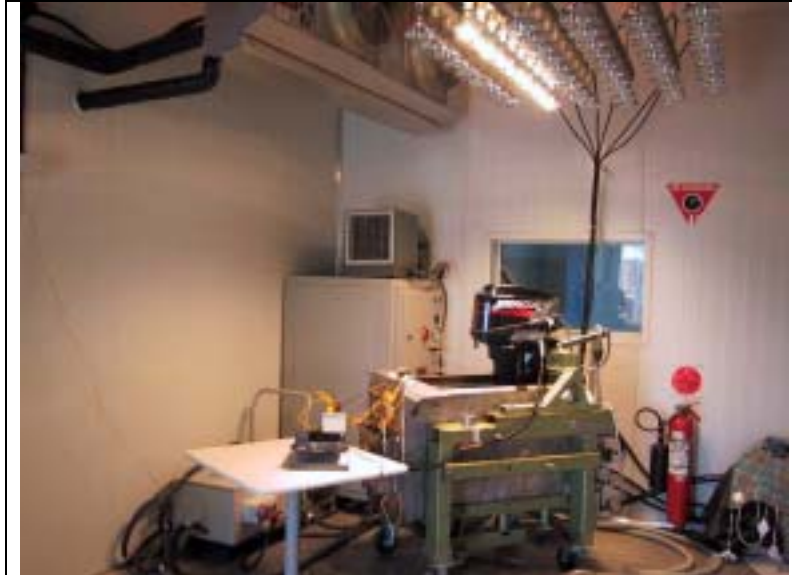
Figure 5.1.9 Marine Engine undergoing Hot Soak

The procedure followed for the hot start was to pre-condition the engine by operating the engine at a fast idle in a portable small tank until the under cowl temperature stabilises at 50°C and the tank water temperature reaches at

least 40°C. The engine is then switched off and soaked for a period to allow heat flow from the engine block into the under cowl cavity until the under cowl temperature stabilises at 55 to 60°C. The heat soaking was undertaken in the environmental test cell that was stabilised at 40°C with the engine positioned under the solar heating lamps (see Figure 5.1.9).

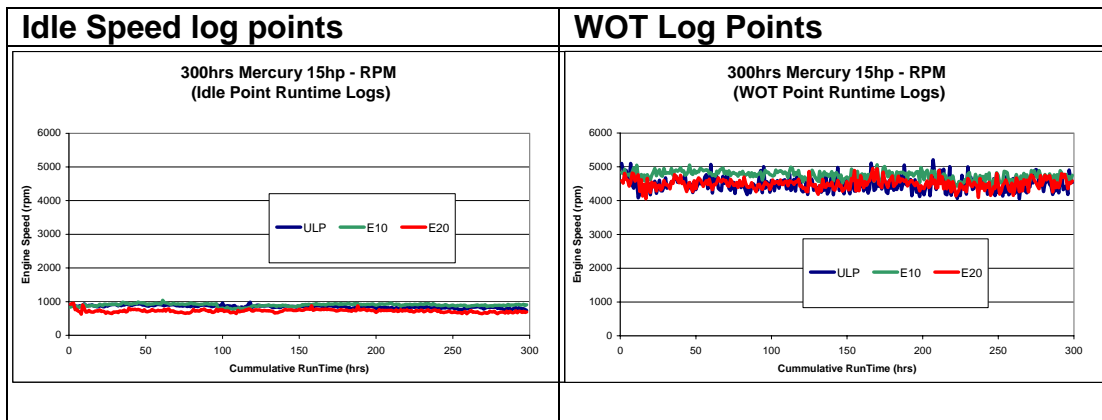
Figure 5.1.10 Marine Engine 300hr Test Log

From the data logged during the durability cycle it is clear that all three engines completed the same duty cycle and test hours and reached similar speeds during the WOT phase, see Figure 5.1.10.

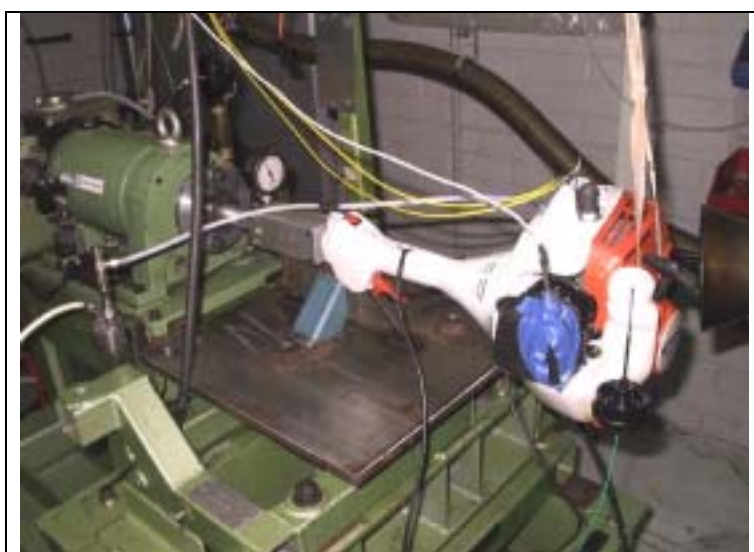
Figure 5.2.1 Utility Engine Dynamometer Testing

All dynamometer performance tests were conducted using the one engine (AENST05) run in the same facility to ensure consistency. Utility engine testing requires that the engine assembly consisting of engine and drive output shaft be assembled and coupled to the dynamometer (see Figure 5.2.1). The assembly thus includes the utility engines drive coupling/clutch and care must be taken to identify any slippage, particularly at low speed.

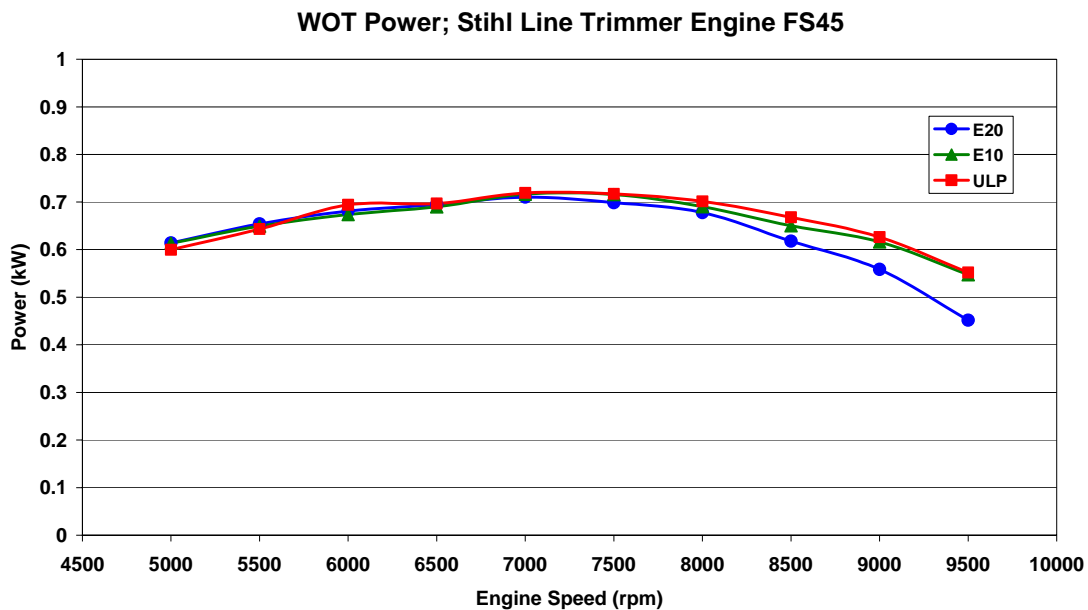
Figure 5.2.2 Utility Engine WOT Power Results

As is evident from Figure 5.2.2, there is little variation resulting from use of the different fuels up to 8000rpm and whilst ULP and E10 perform equally throughout the speed range, the E20 data shows a significant drop in performance at higher speeds. The trend with E20 is outside the variability generally experienced during assessments with this engine and is expected to be a true shift in performance. The power deficit measured with E20 can be attributed to increasing enleanment of the mixture as evidenced by the equivalence ratio decrease for the E20 shown in Figure 5.2.4.

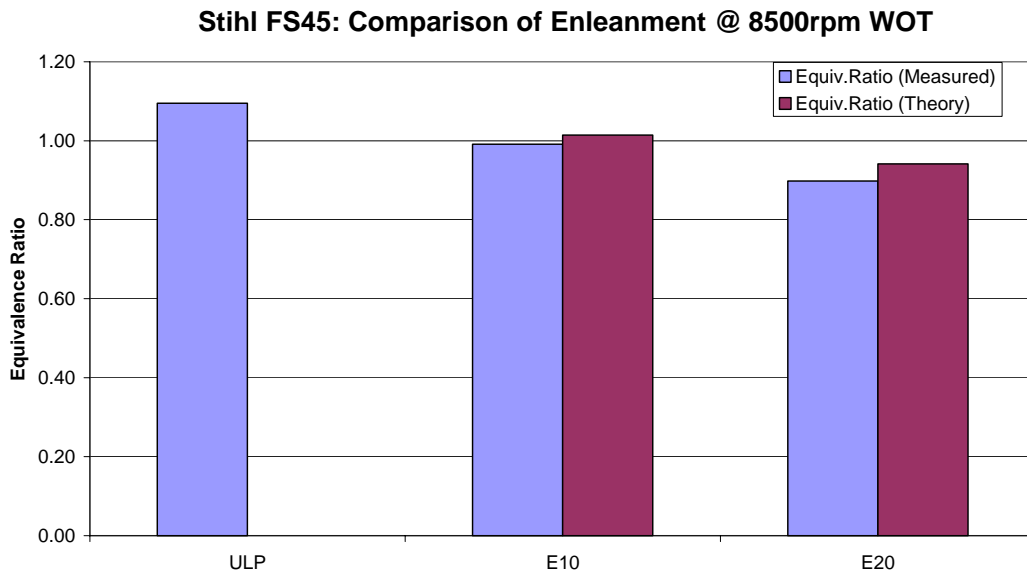
Figure 5.2.3 Utility Engine Enleanment Results – Power Test

The theoretical enleanment due to the addition of ethanol in the fuel blend is compared to the measured results at one point in the engine power test in Figure 5.2.3 and shows reasonably good correlation between measured and theoretical equivalence ratios for the E10 fuel blend. However, the correlation is not as good with the E20 blend, with measured results showing more

enleanment than expected. This result was opposite to that observed during the emissions testing (conducted at an engine speed of 8300rpm).

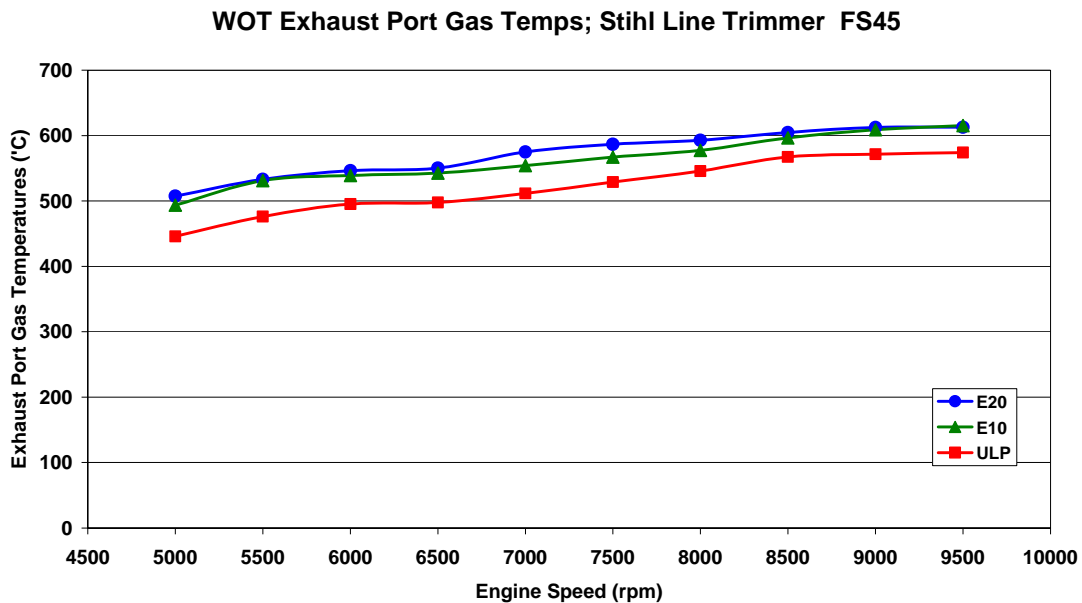
Figure 5.2.5 Utility Engine WOT Exhaust Port Gas Temperatures

Examination of exhaust port gas temperatures highlights that the temperature does increase as a result of the use of ethanol in the fuel blend, however the incremental increase with increasing ethanol proportion is not as clear for the

utility engine as it was with the marine engine, see Figure 5.2.5. Based on the data collected, the lack of incremental increase for E20 is most likely due to the equivalence ratio of the mixture falling significantly below 1.0 (a very lean mixture) which can theoretically result in little change or reduction in exhaust gas temperature if sufficient enleanment is encountered. This is due to the excess air effectively absorbing some of the energy released from the combustion event. The resulting exhaust gas temperatures are therefore lower than what would be expected due to slight enleanment from a richer than stoichiometric base condition.

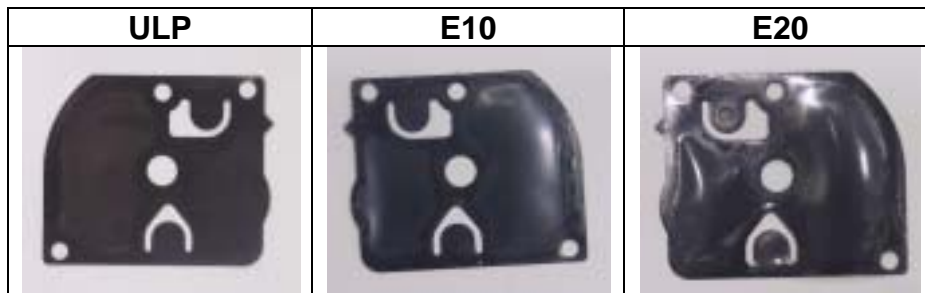
Figure 5.2.10 Utility Engine - Carburettor Lower Diaphragm

The carburettor lower diaphragm showed signs of swelling and blistering that, although negligible for ULP, was slight for E10 and severe for E20 fuels (see Figure 5.2.10). This has the potential in the longer term to lead to loss of internal or external sealing which in turn could lead to fuel leakage, engine

damage and engine stoppage. However, such terminal failure did not result with the E10 and E20 test engines.

- The Stihl engine carburettor diaphragm was found to suffer severe distortion and blistering. This has the potential to result in loss of internal and external sealing which may in turn lead to fuel leakage. This result is considered unacceptable as it clearly indicates that the diaphragm material is not compatible with the E20 blend fuel.

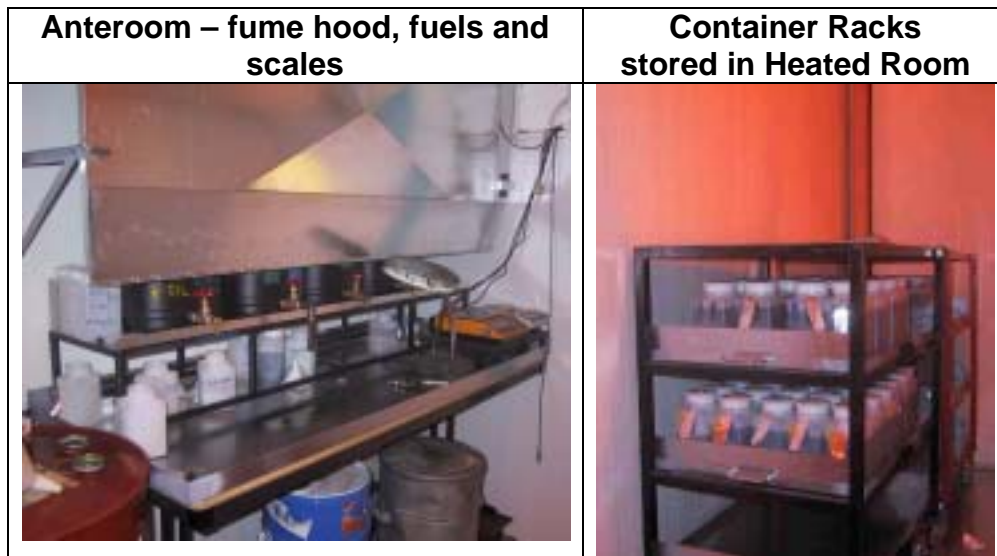
Figure 6.2.1 Materials Compatibility Test Facilities

- The test cell is controlled to 55+/-2°C (SAE standard for material testing) and the anteroom is controlled to 23+/-2°C (SAE standard for component measurement). Temperature control of the test cell and anteroom has been validated over an extended period.
- The anteroom has been modified to incorporate a bench with fume hood and extraction system (see Figure 6.2.1). This bench is used for sample preparation and condition assessment throughout the test period.
- Fuel drums (with taps) and racks have been fitted to the bench to facilitate replenishment of each fuel type. A waste fuel drum on wheels is located next to the bench.

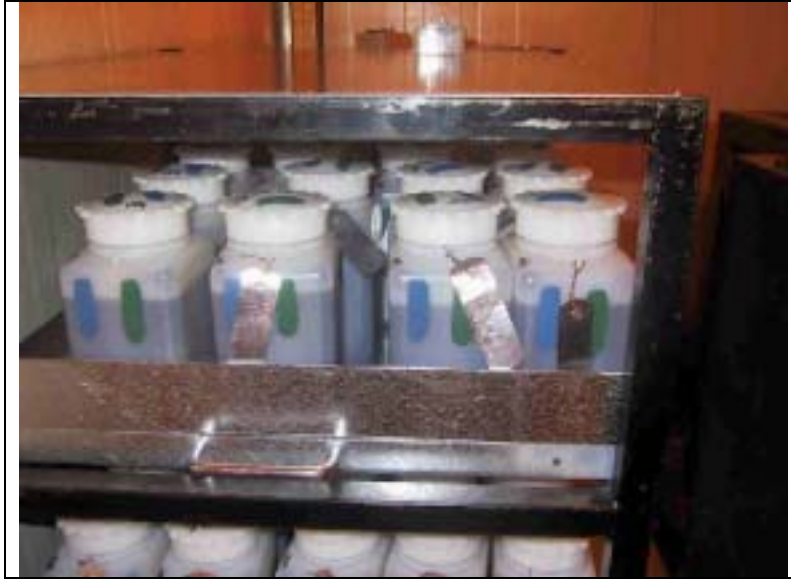
Figure 6.3.1 Test Samples in Containers

The progress to date has been delayed due to a number of logistical concerns that have only recently been resolved. All facilities preparations have now been completed, test procedures documented and component samples purchased and prepared (see Figure 6.3.1).
