Desktop review – Impact of bushfires on water quality

For the Australian Government Department of Sustainability, Environment, Water,
Population and Communities

18th March 2011

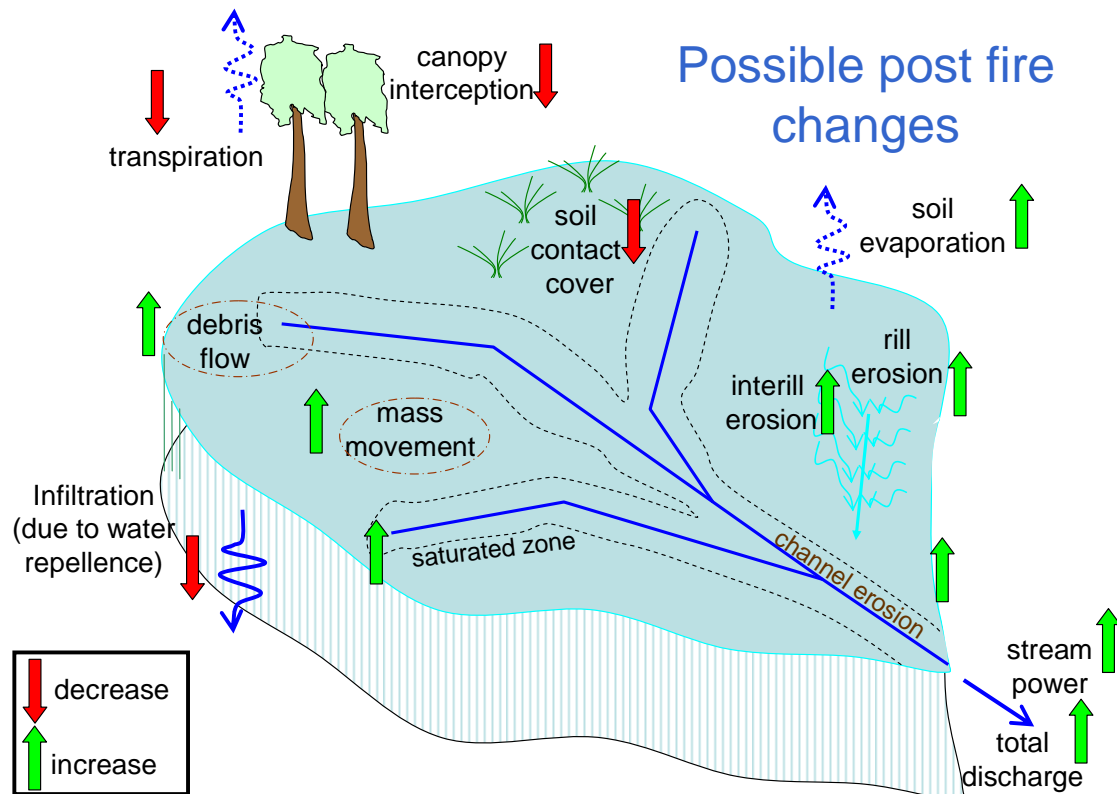
Figure 1: Schematic diagram showing possible post-fire changes in hydrologic and erosion processes.

A number of processes can cause water quality impacts following fire. In this section, we briefly review these processes and the key factors influencing them (Figure 1).

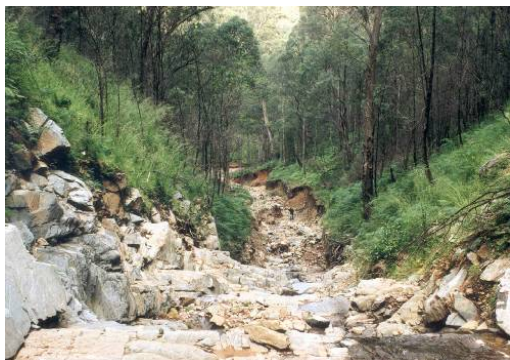
Figure 2: Channel scoured by a post-fire debris flow in a tributary of the Upper Buckland River, Victoria, which was burned in 2003. (Photo: Gary Sheridan).

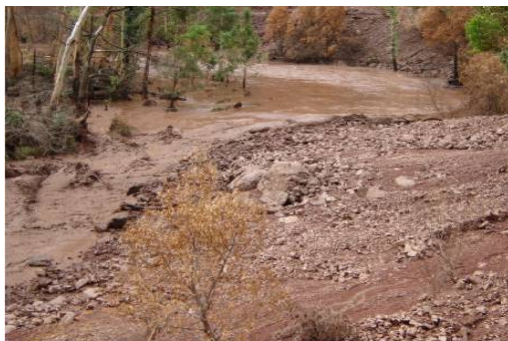
Figure 3: Flow downstream of a post-fire debris flow in the Wellington River (above the junction with the Macalister River). (Photo: Adrian Murphy, Melbourne Water).

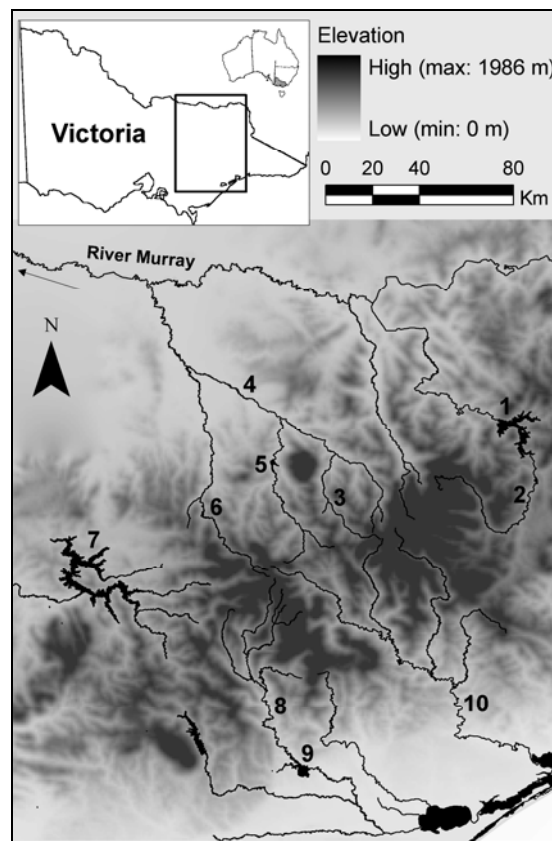
Figure 4: Map of eastern Victoria showing rivers and reservoirs impacted by bushfires in 2003 and 2006/07. Number labels refer to: 1) Dartmouth Reservoir; 2) Mitta Mitta Reservoir; 3) Buckland River; 4) Ovens River; 5) Lake Buffalo; 6) Lake William Hovell; 7) Lake Eildon; 8) Macalister River; 9) Lake Glenmaggie; 10) Mitchell River.

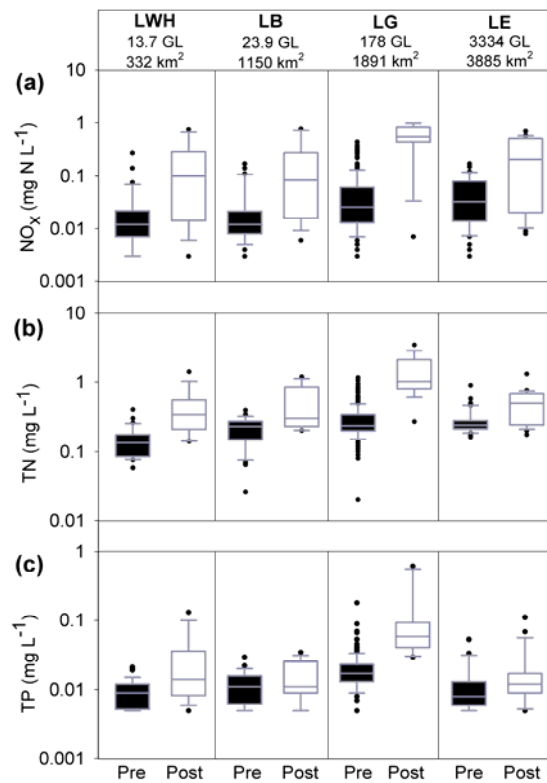
Figure 5: Box plots of pre and post-fire two-four weekly measurements of a) NO_x, b) TN and c) TP in four reservoirs (LWH: Lake William Hovell; LB: Lake Buffalo; LG: Lake Glenmaggie; LE: Lake Eildon) with catchments burnt by bushfire in 2006-07 in Victoria, south-eastern Australia. Box plots display the 10th, 25th, median, 75th, 90th percentiles and outliers. Data supplied by the Goulburn-Murray Water Authority and the Victoria Water Resources Data Warehouse.

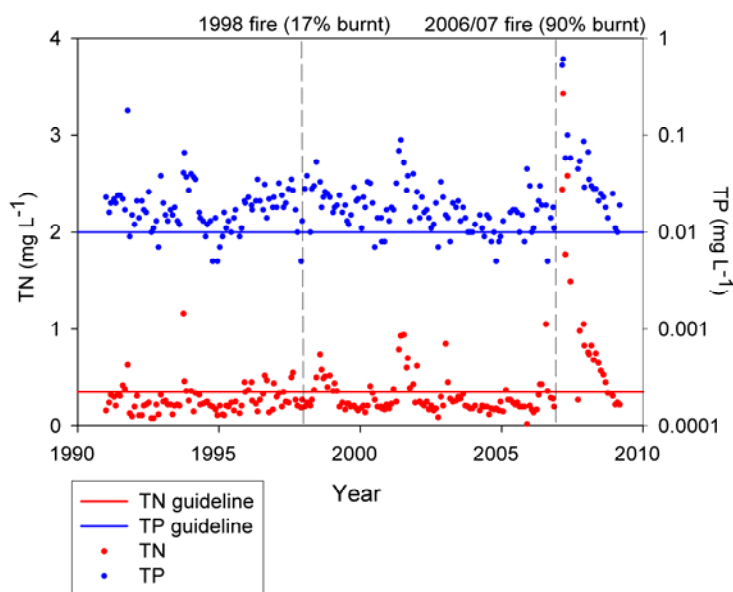
Figure 6: Monthly TN and TP concentrations measured at the Lake Glenmaggie outflow before and after bushfires in 1998 and 2006-07, Victoria, south-eastern Australia. Note the difference in axis scales between TN and TP. Data accessed through the Victoria Water Resources Data Warehouse.

The largest recorded post-fire impact on reservoir water quality occurred in Lake Glenmaggie (catchment 90% burnt) following a debris flow (February 2007) and a subsequent high magnitude flood (June 2007), resulting in persistent poor water quality in the reservoir, with TN and TP concentrations in outflows only approaching pre-fire levels after three years (Figure 6).

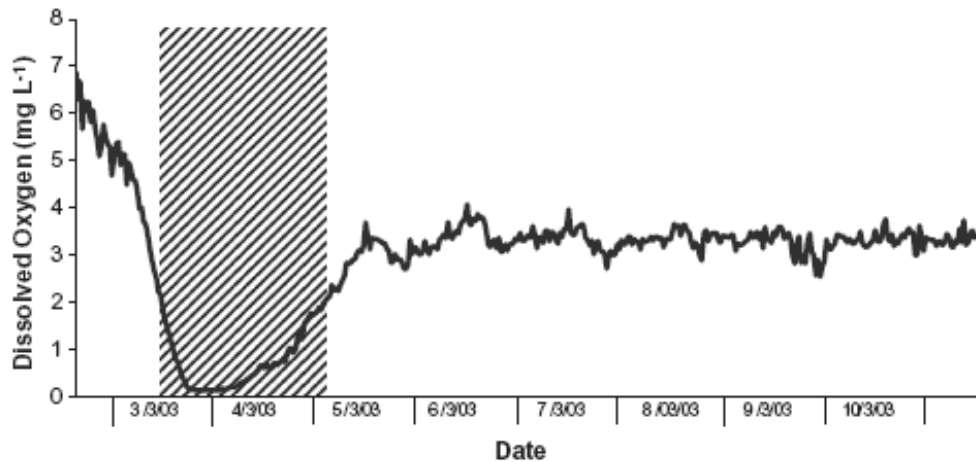
Figure 7: Dissolved oxygen concentration in the Ovens River at Tarrawingee (north-east Victoria) before, during and after a pulse of sediment passed down the river as a result of post-fire debris flows further upstream. The shaded area indicates the head of the sediment slug passing downstream through the Tarrawingee area. Source: Lyon and O'Connor (2008).

Lyon and O'Connor (2008) measured dissolved oxygen in the Ovens River about 70 km downstream of post-fire debris flows in the Upper Buckland River in north-eastern Victoria (Figure 7). Concentrations as low as 0.2 mg L^{-1} that lasted for 12 hours were recorded during the initial pulse of sediment caused by the debris flow. Over subsequent days, the dissolved oxygen concentrations remained at levels lower than were recorded before the pulse of sediment entered the river.

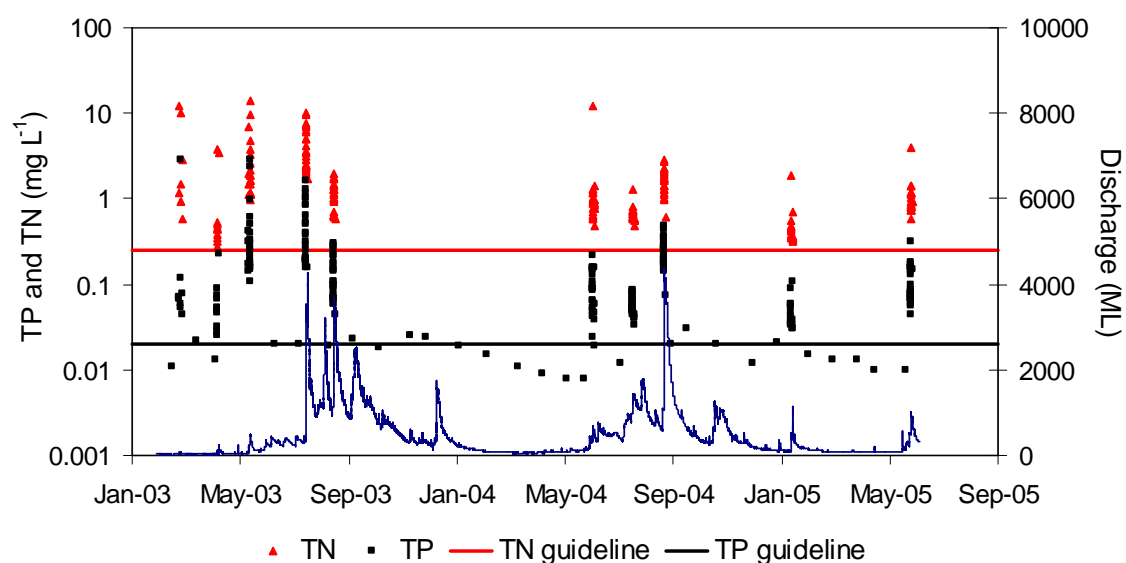
Figure 8: Comparing guideline values to total nitrogen and total phosphorus concentrations for the Ovens River at Bright (north-east Victoria) following the 2003 bushfires (data provided by North East Water).

- in the Ovens River at Bright, upstream of the impact of post-fire debris flows, post-2003 fire maximum TN concentrations were 56 times the guideline value and TP concentrations were 145 times the guideline value. During the subsequent 2.5 years, TN and TP concentrations in the Ovens River at Bright exceeded the guideline values during all automatically sampled flow events (Figure 8), and
